WASTE WATER TREATMENT PLANT
AL KASIK MILITARY TRAINING BASE
AL KASIK, IRAQ

SIGIR PA-06-074
JANUARY 29, 2007

SUBJECT: Report on Waste Water Treatment Plant, Al Kasik Military Training Base, Al Kasik, Iraq (Report Number SIGIR PA-06-074)

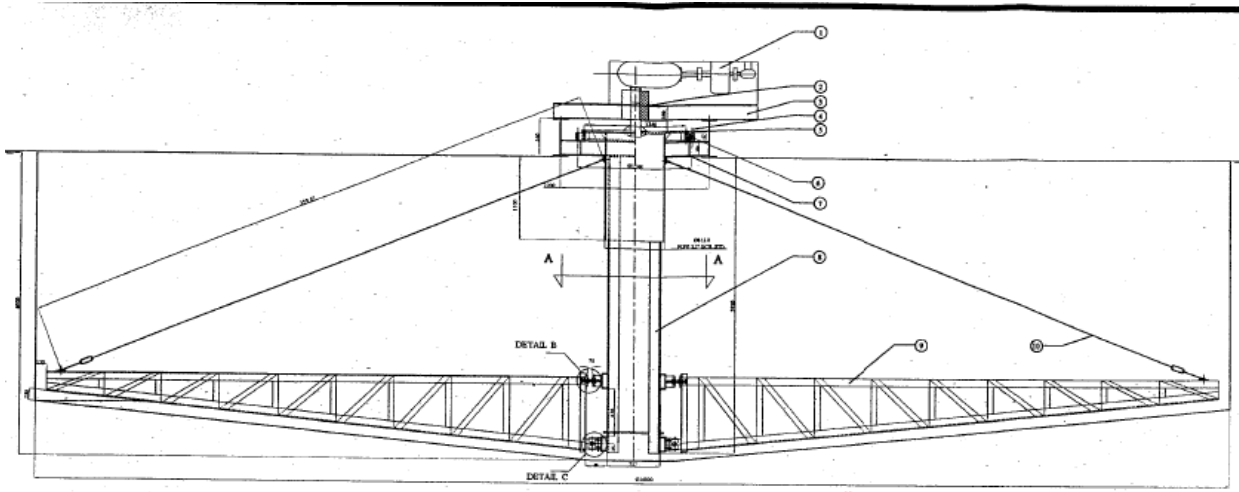
Diagram 1. Diagram from contractor's submittal A-106 for clarifier torque calculations. The diagram does not show a vertical skimmer arm attached to the sweep arm.

In that the skimmer structure was not part of the original design, engineering load calculations were likely understated. Changes in the design, such as the addition of the skimmer structure, altered the boundary conditions for the original torque analysis of submittal A-106. The absence of a properly calculated design change to account for the addition of the skimmer structure during construction was likely the catalyst for the series of failures that rendered the clarifier tank inoperable.

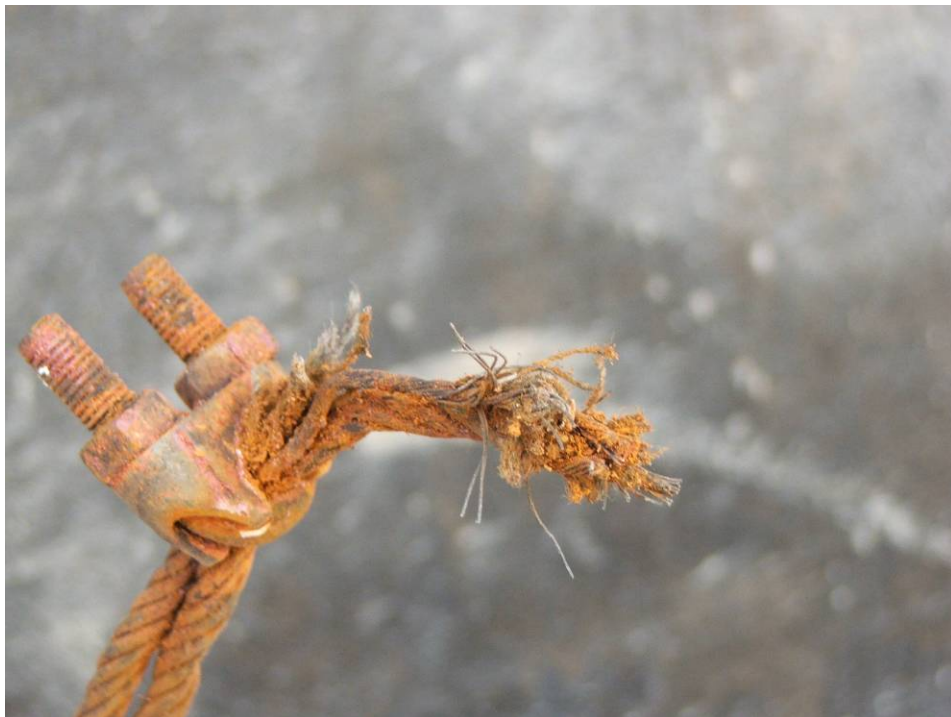
Site Photo 2. Support cable was frayed and corroded.

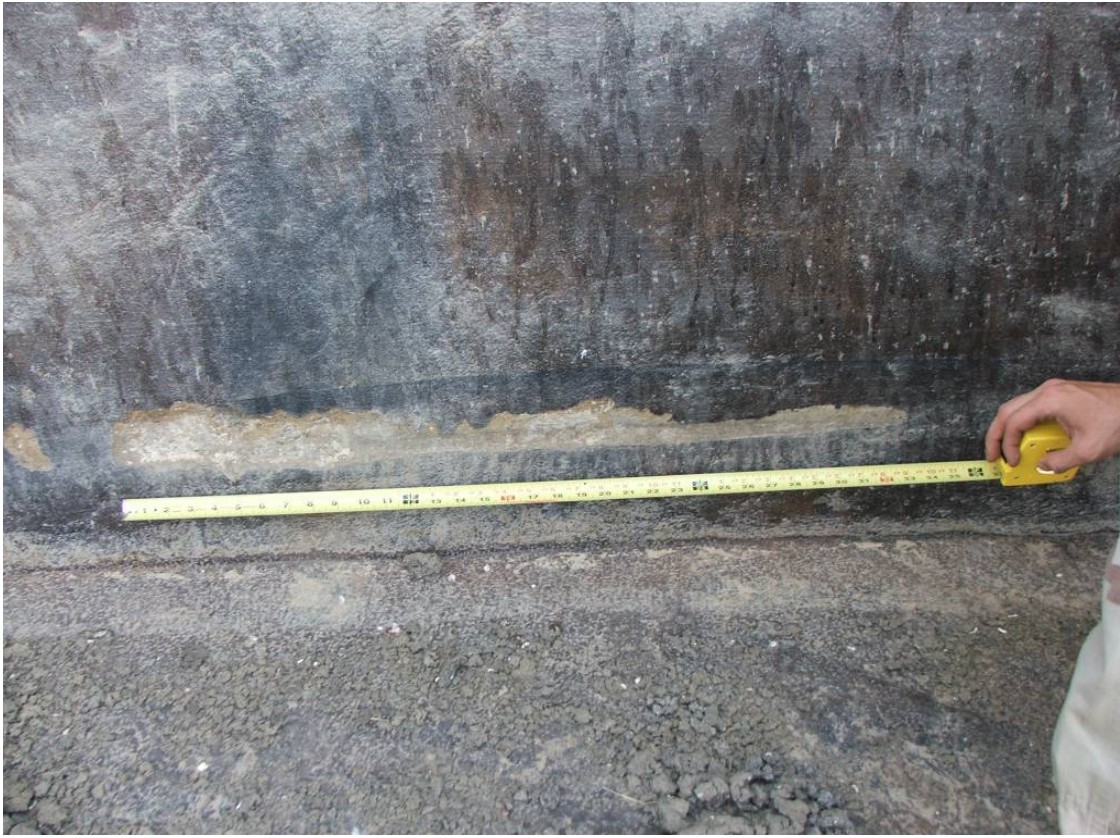
The assessment team observed a scrape or gouge approximately 33 inches long in the wall of the clarifier tank (Site Photo 3) while a thin buildup of wall material remained on the leading edge of the scraper arm (Site Photo 4). No other similar scrapes were observed elsewhere in the clarifier tank. It would be reasonable to conclude that the supporting cable failure caused the scraper arm to fall and position the scraper arm against the tank wall while the arm was in motion and in contact with the floor. Accordingly, it is likely that subsequent gear box failure occurred quickly while the arm was in contact with the tank wall.

Site Photo 3. Gouge mark approximately 33 inches long.

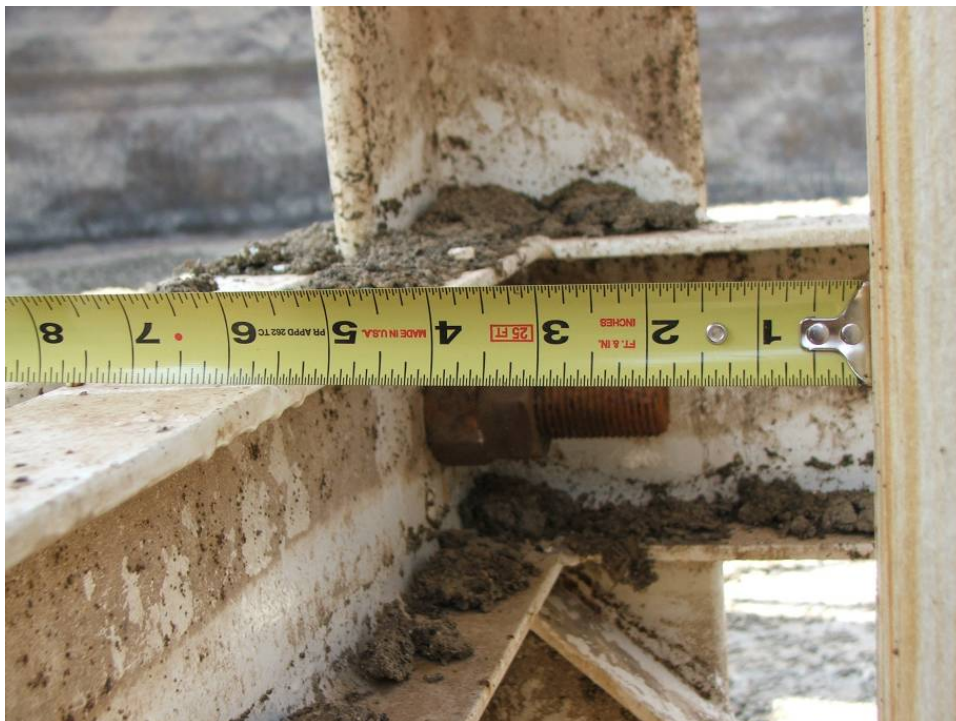
The main vertical supporting shaft of the rotating scraper arms was observed to be off center by over 2 1/8 inches. Site Photos 5 and 6, show the off center position of the main vertical shaft following the break down of the scraper arm assembly.

Site Photo 5. Main shaft was positioned approximately 5 5/8 inches from the static frame.

Site Photo 6. Main shaft was positioned approximately 2 7/8 inches from the static frame.

The off center vertical shaft was an indicator of an asymmetrical shaft load. The main shaft moved from center because of an unbalanced load caused by the added weight of the vertical skimmer structure attached during construction to one side of the horizontal scraper arm assembly. Conversely, the opposite side of the horizontal scraper arm assembly did not include a counterweight to offset the weight of the skimmer structure and unbalanced state of the horizontal sweep arm. In addition, an undetermined amount of additional drag force was created as the skimmer structure moved through the tank's liquid while the horizontal sweep arm assembly rotated. Accordingly, the overall load placed on the horizontal sweep arm assembly and drive gearbox likely increased substantially by the addition of the vertical skimmer structure. Simply put, the vertical skimmer structure attached during construction was big and heavy and caused the structure to be unbalanced. Diagram 2 illustrates the movement of the vertical shaft because of the unbalanced load on the horizontal sweep arm assembly. QA Photo 10 presented later in this report shows the skimmer assembly from the top while Site Photo 7 shows the skimmer from inside the tank.

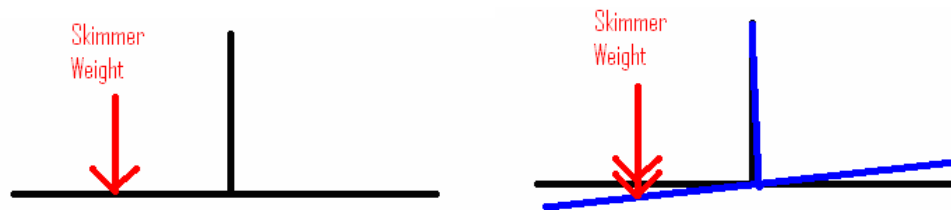
Diagram 2.

An unbalanced load on the horizontal arm assembly caused stress on the vertical shaft which forced the shaft to an off center position.

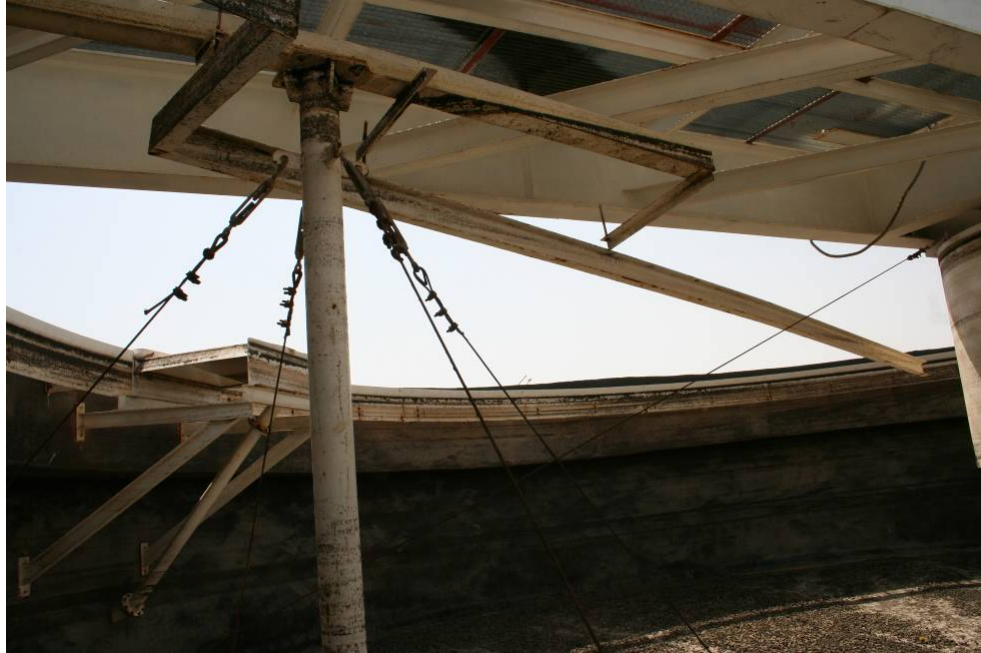
Site Photo 7. Skimmer structure viewed from inside the tank.

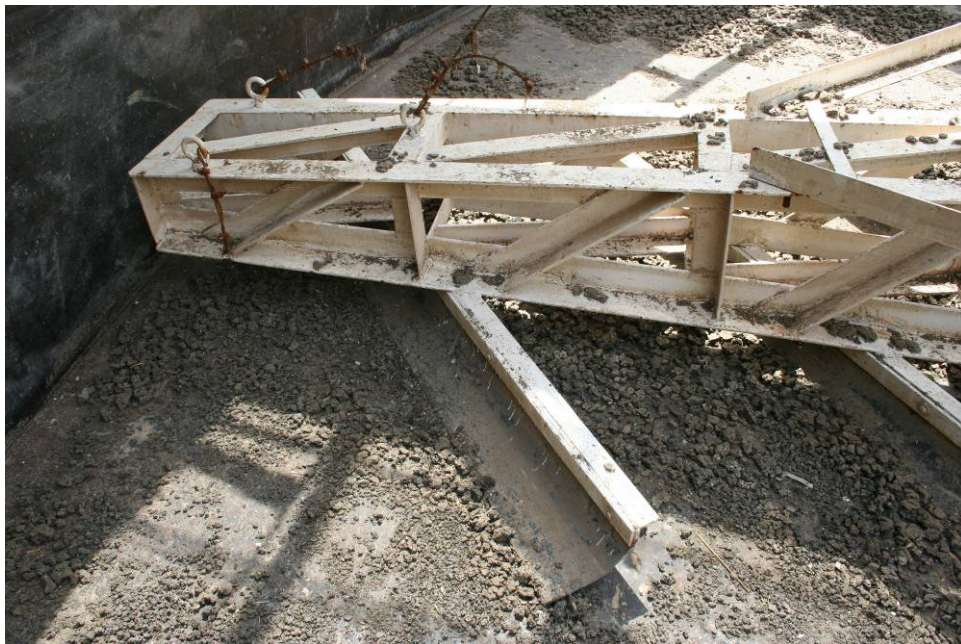
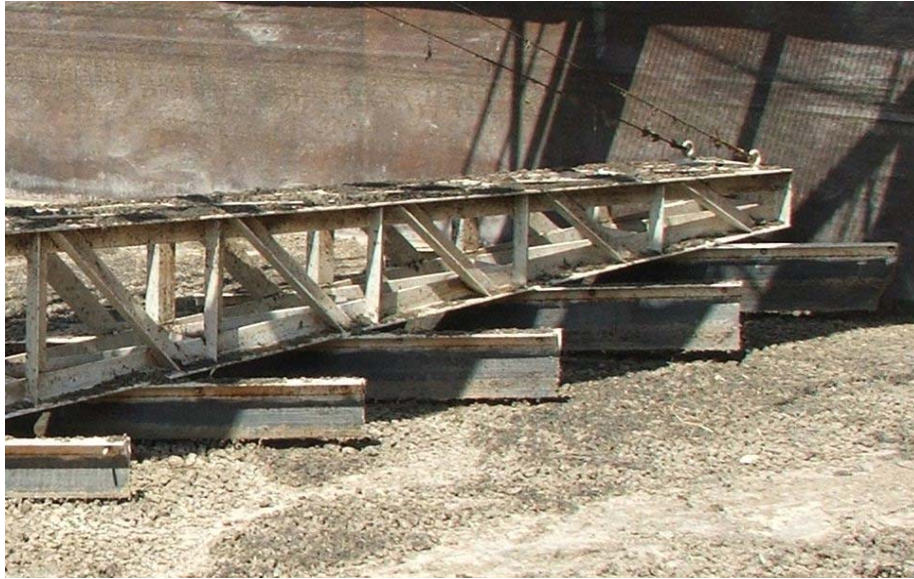
Site Photos 8 and 9 show the difference in clearance distance between the floor and each side of the horizontal sweep arm assembly. Site Photo 8 shows the side that dropped when the cable failed. In Site Photo 8, the rubber scrapers were bent and in full contact with the floor. Conversely, Site Photo 9 shows the opposite side that did not experience cable failure. As such, the rubber scrapers shown in Site Photo 9 are not bent and hang freely above the floor by approximately 2 to 3 inches. If properly balanced, such rubber scrapers should gently touch the floor in order to sweep the floor during rotation of the horizontal sweep arm assembly.

Site Photos 8. Rubber scrapers contact the floor on side that experienced cable failure.

Site Photo 9. The rubber scrapers hang freely on the side that did not experience cable failure.

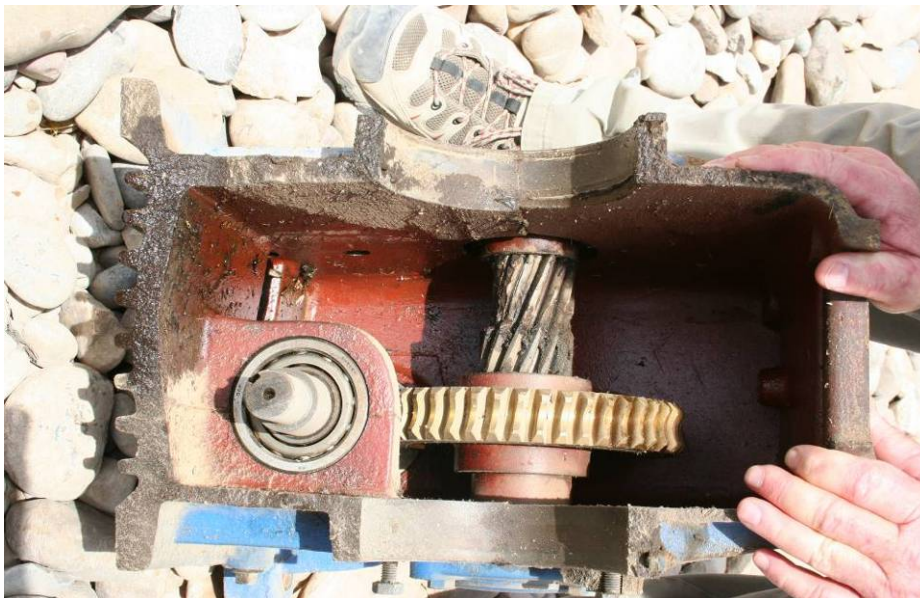
Immediately following the cable failure and subsequent contact between the dropped side of the horizontal sweep arm assembly and tank wall and floor, the clarifier gearbox, for all practical purposes, completely failed. The gearbox was lying in two pieces at the base of the clarifier tank. A fracture that bisected the gearbox housing ran the length of the cast metal casing. The oily coating and a distinct oil line observed indicated that the gearbox was operated with adequate lubrication before failure. Site Photo 10 shows the broken gear and fractured gearbox case. Based on the assessment team's observations of the failed cable, the off balanced horizontal sweep arm assembly, the off center vertical main shaft, the broken condition of the gearbox, discussions conducted with plant operators and Coalition Military Assistance Training Team/Regional Support Unit (CMATT/RSU) personnel, and a review of maintenance documentation (modest as it was), it is very unlikely that the gearbox failure was due to inadequate lubrication.

Site Photo 10. "Chewed/sheared" gear teeth and a fractured gearbox case illustrate that abnormal force broke the gear box.

Based on the assessment team's observation, a review of relevant documentation, and discussions conducted with WWTP operators and the AFCEE/COR, the assessment team concluded that the likely root cause of the break down of the clarifier tank was the addition of the vertical skimmer structure during construction without proper redesign to compensate for the added load placed on the supporting cable. After the cable broke, the sweep arm assembly dropped and made contact with the floor and wall. At that point in time, stresses quickly escalated and the gear box failed because a fail-safe system (shear key) was not included in the design and the installed magnetic contactor overload relay did not function properly and shut down the motor.

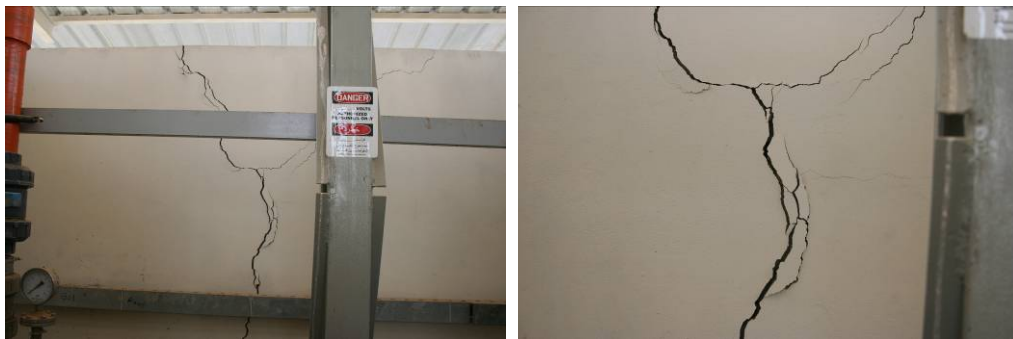
Site Photos 11 and 12 show that sizeable vertical cracks crept up the rear wall of the pump station.

Site Photos 11 and 12. Vertical cracks were present in the inner rear wall of the pump station.

Based on the assessment team's observations, a review of design and QC documentation, and discussions conducted with the CMATT/RSU Engineer and the AFCEE/COR, the number of cracks of such magnitude indicated that abnormal stress was distributed across the rear concrete wall of the structure. In addition, such cracks were likely caused by, either/or a combination of, insufficient steel reinforcement of the concrete or inadequate soil compaction. The horizontal cracks that ran from corner to corner of the rear wall indicated that settling of the base slab was very likely. Inadequate soil compaction could cause such settling. Even if properly reinforced, much less if not sufficiently reinforced, the concrete wall would have been prone to cracking if constructed on soil that was not sufficiently compacted.

During fieldwork discussions, the AFCEE/COR agreed that the pump station should be reconstructed to prevent continued degradation of the pump station and as a hedge against future failure in the G-03 pump station.

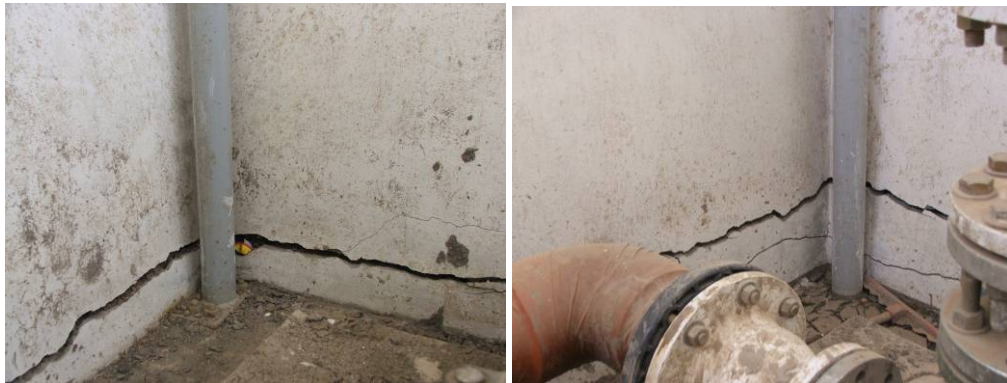
Site Photos 15 and 16. Horizontal cracks near the floor at opposite corners of the G-03 building.

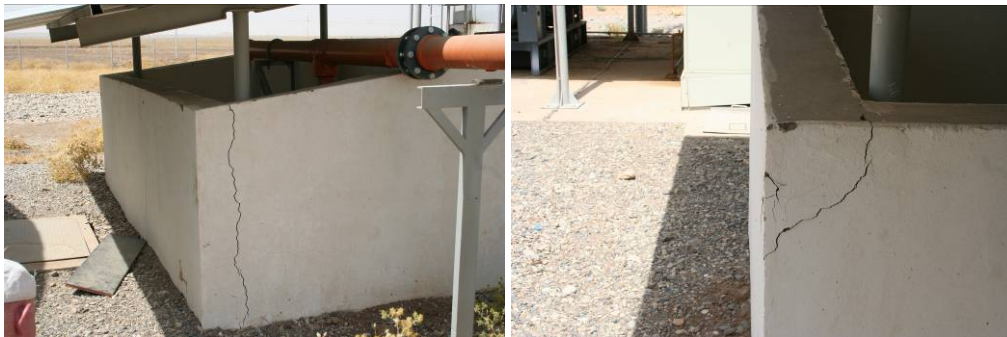
Site Photos 17 and 18 illustrate that the cracking extended all the way from the bottom to the top and from the inside to the outside of the structure's rear wall.

Site Photos 17 and 18. Vertical cracks wound their way to the outer corners of the rear wall.

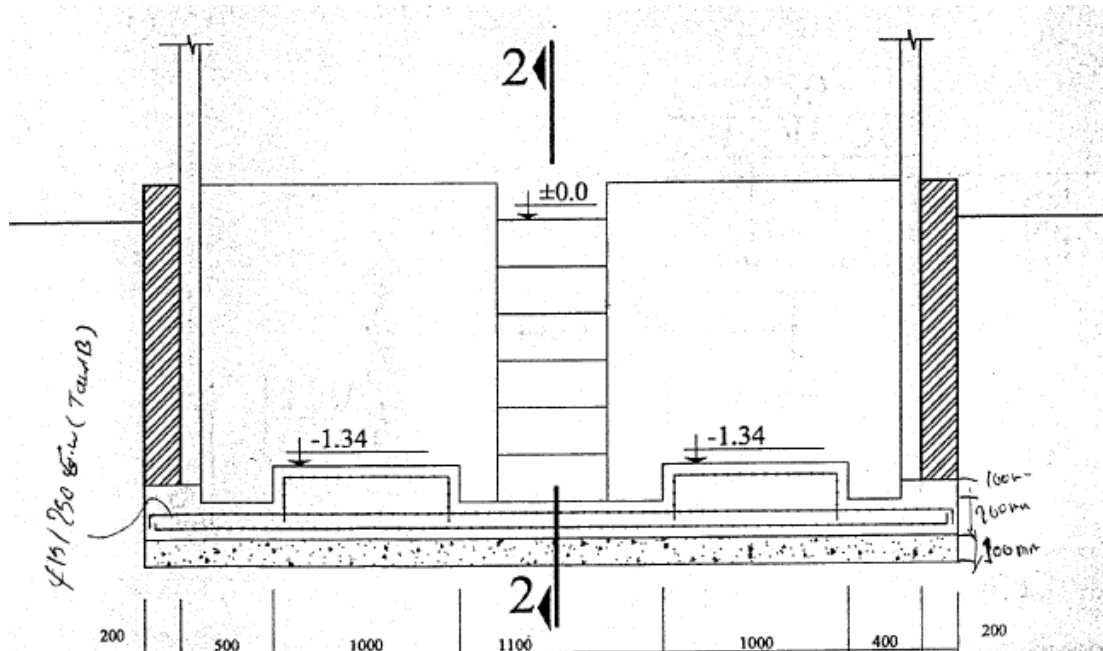
During a review of design and Quality Control documentation, the assessment team found contractor's submittal A-41, G-03 pump pad details, (Diagram 4) with comments that specified the BRC #63 should be replaced with steel bar reinforcement.

Diagram 4. Cross section of G-03 building from the contractor's A-41 submittal.

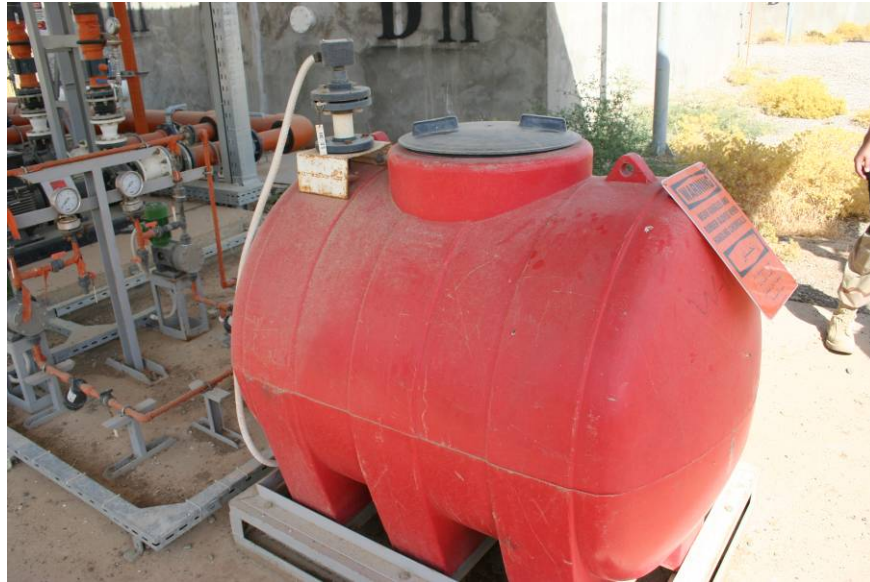
Site Photos 19. Chlorination system included a holding tank for Sodium Hypochlorite (NaOCL).

According to the EPA Chlorine Disinfection fact sheet, 85 degrees Fahrenheit is the maximum (not to exceed) temperature in which liquid NaOCL should be stored. At the time of the assessment team's visit, temperatures were well above 100 degrees Fahrenheit. Obviously, the temperatures routinely experienced in Iraq during the hot season exceed the EPA 85 degree Fahrenheit threshold.

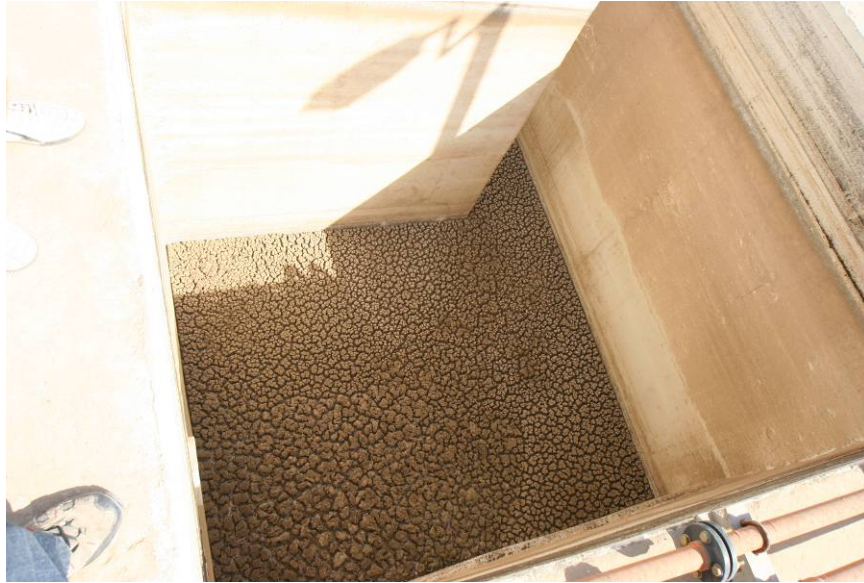
During the assessment team's visit, it was noted that the contact tank contained dried, suspended solids that were visible on the floor of the tank. Site Photo 20 shows the solids observed. While suspended solids are a normal part of unfiltered effluent processed in any waste water treatment plant, the unfiltered solution is normally not chlorinated because suspended solids interfere with the efficiency of a chlorination process. In the case at hand, chlorine was added before the effluent had effectively passed through the pressure filters, which would have removed suspended solids. The design, as built, exposed the suspended solids to chlorine in the contact tank.

Based on information from the EPA Chlorine Disinfection fact sheet, high levels of suspended solids entrap residual bacteria and interfere with the efficiency of wastewater disinfection. In addition, the Standard Handbook for Civil Engineers cites that "The last step in secondary treatment of wastewater is disinfection of the effluent to kill pathogenic (disease-causing) bacteria and viruses." In contrast to the pre-filter system built at the Al Kasik WWTP, a post-filter contact tank system might have been a more efficient system to use.

Site Photos 20. Prefilter chlorination tank floor was covered with solids.

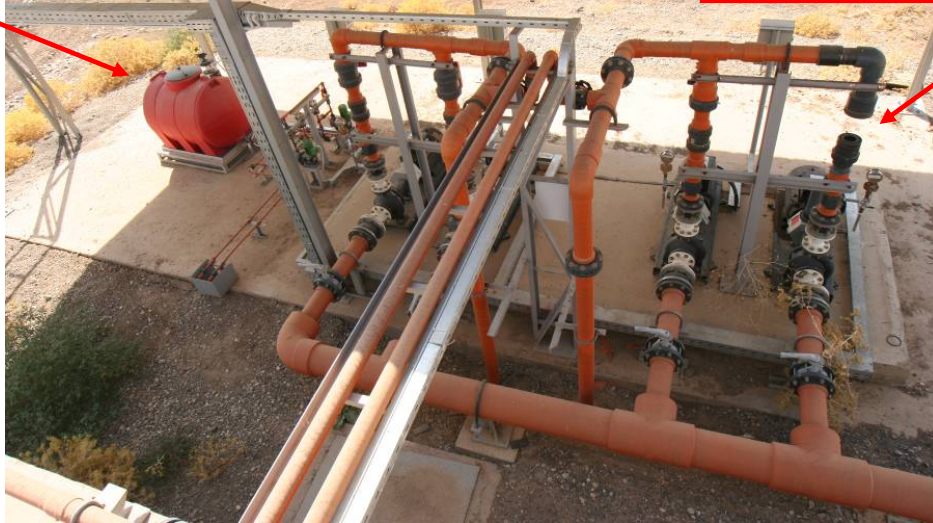
Back Flush Side Showing Missing Nipple.

Site Photo 21. Effluent supply and back flush inlet piping systems.

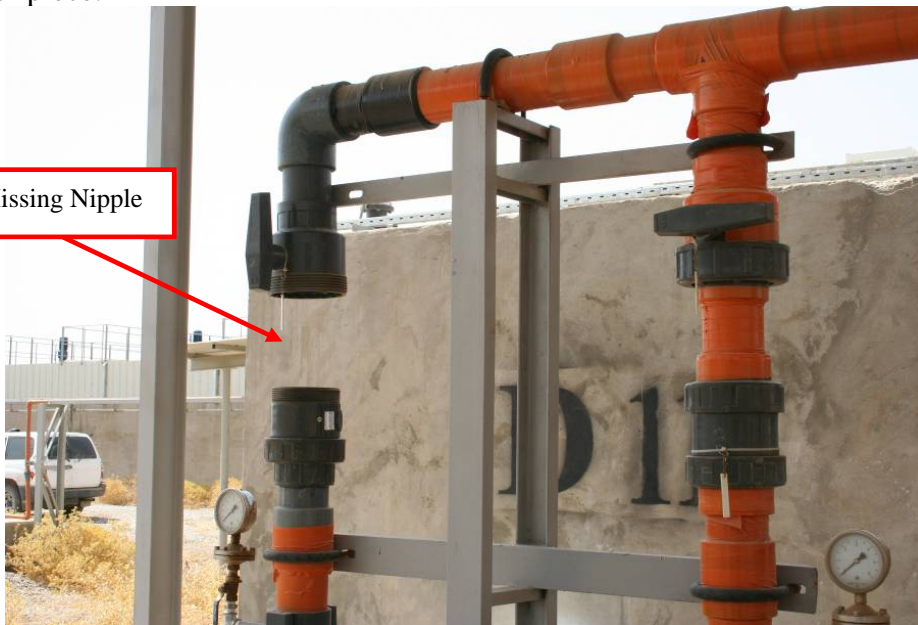
Missing Nipple

The assessment team observed that a pipe nipple on the back flush side of the inlet system was missing. A backup or spare nipple was not a required element of the Task Order and the WWTP operators claimed that the non-standard sized nipple could not be purchased locally. As a result, back flush operations could not be performed. Site Photo 22 shows the back flush inlet line was missing the relatively minor piece.

Site Photo 22. Missing nipple meant that back flushing could not be performed.

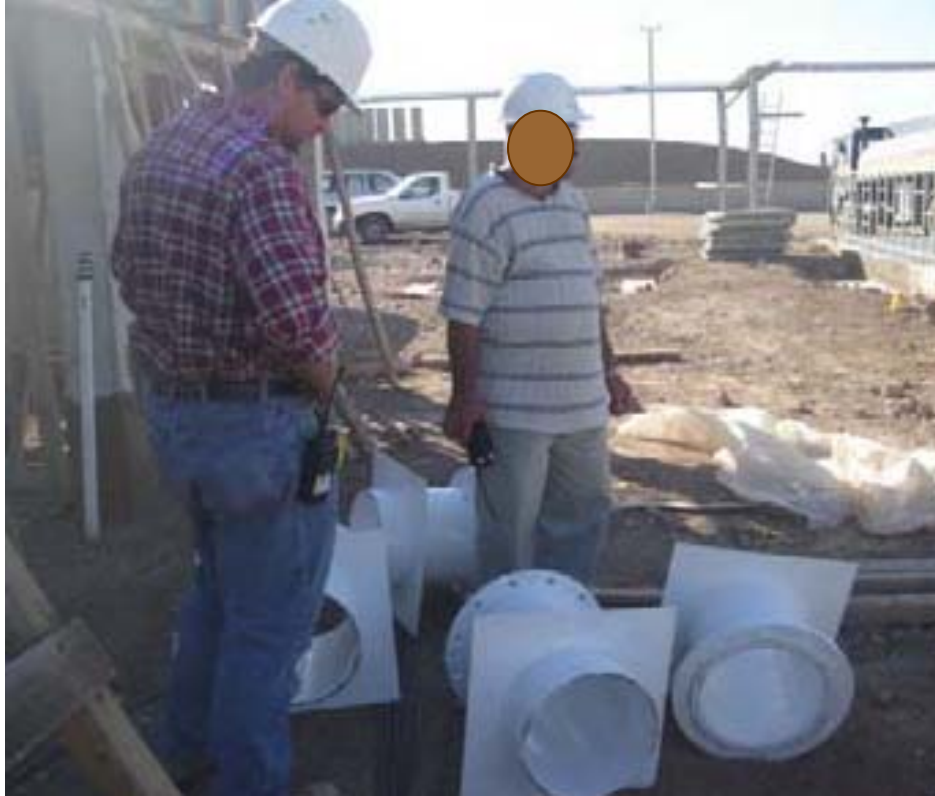
QA Photo 3. QC Manager inspected and rejected pipe flanges (from QA Report 11 Sep 2005).

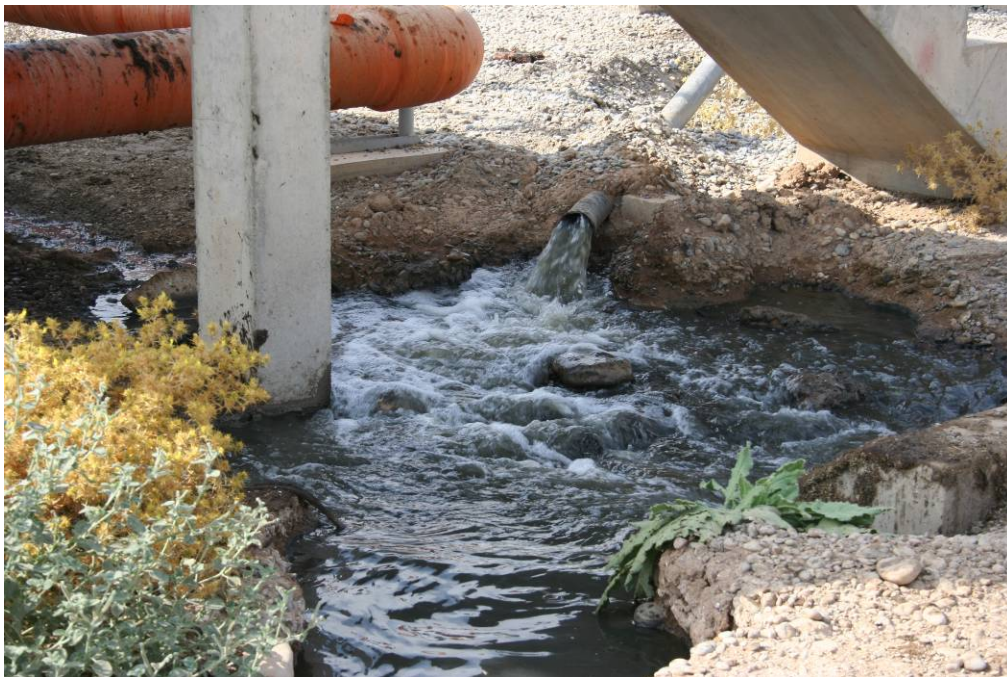
As a result of the failure of the clarifier, the WWTP was rendered inoperable and all waste water input was pumped directly off the site. Site Photo 23 shows raw sewage being pumped off the site.

The project objective to plan and construct a waste water treatment plant compliant with World Health Organization 2000 Specifications for waste water treatment capable of handling peak and minimum flows with sufficient storage tanks upstream and downstream to satisfy system demand was not fully realized. Specifically, the sweep scraper assembly in the D-7 Clarifier Tank experienced catastrophic failure only 34 days after acceptance by government officials on 13 February 2006. As a result, the WWTP has not operated as planned from 19 March 2006, when the D-7 scraper arm broke down, to 8 August 2006 when the assessment team conducted the site visit. Until repaired, raw sewage in excess of the daily holding capacity of the facilities D-1 tank will continue to be pumped off the facility (Site Photo 23) to the country side via a surface ditch creating a potential health hazard to local people and ground water supplies.

Site Photo 23. Raw sewage pumped off site via surface ditch.
